# Restoration Guide for Historic Log Buildings on the Trail of Tears National Historic Trail

National Park Service  
Trail of Tears National Historic Trail  
MTSU Center for Historic Preservation

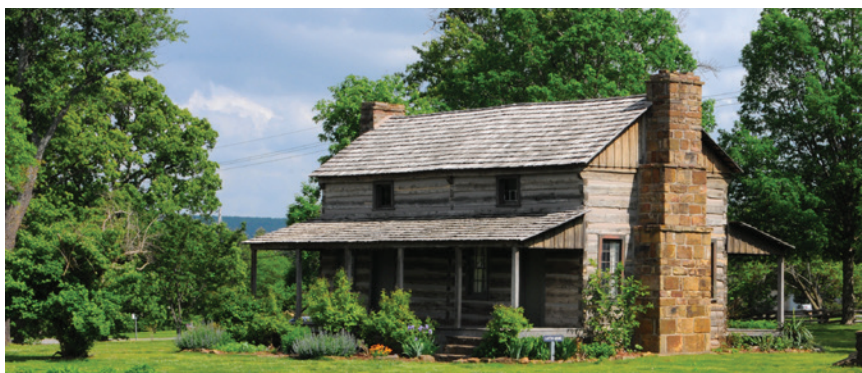
*The Bell detachment disbanded near the ca. 1834 Latta House (Vineyard Post Office) on January 7, 1839. The two-story, double-pen log house was moved from its original location to the Prairie Grove Battlefield State Park in Washington County, Arkansas, in 1958.*

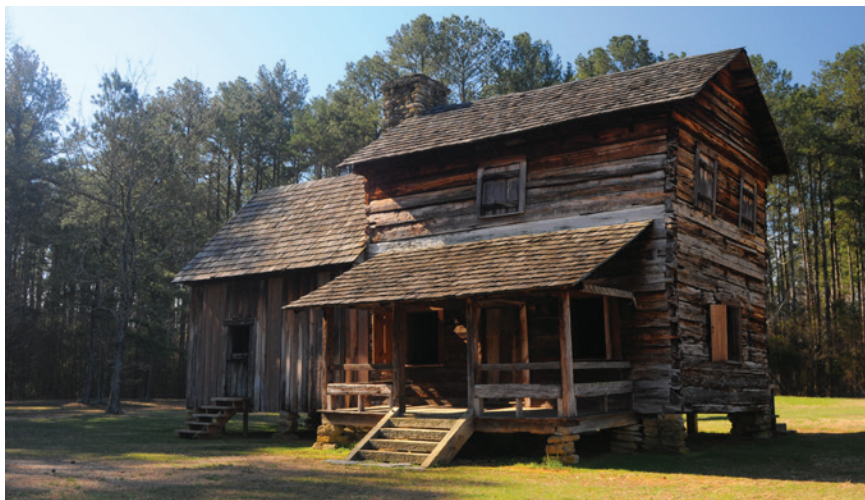
*Cherokee James Vann built this two-story hand-hewn log tavern around 1805. It has a single room on the first floor and three rooms on the second floor accessible by an external staircase at the rear. A one-story board-and-batten room was added to the east side at a later date. The tavern was moved to the New Echota State Historic Site in Gordon County, Georgia, in 1955.*

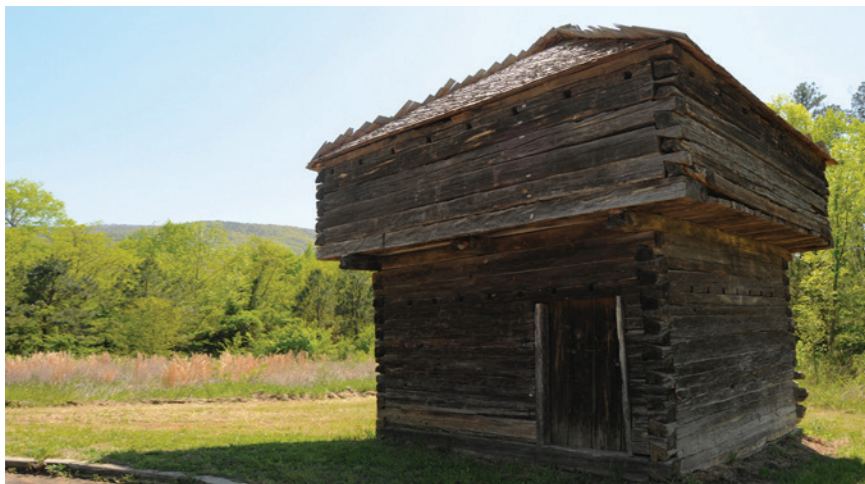
*The Fort Morrow Blockhouse in Polk County, Tennessee, is the only known example of cantilevered log architecture on the Trail of Tears.*

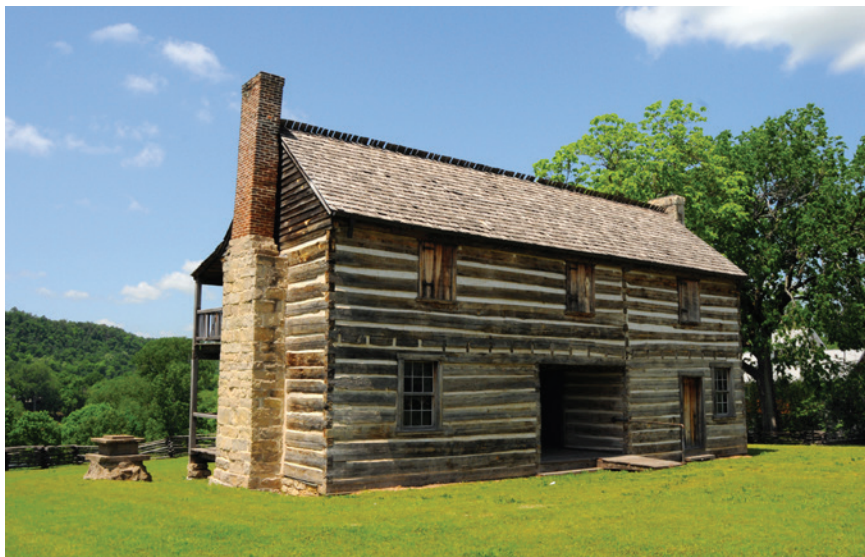
*The Wolf House in present-day Norfolk, Arkansas, was built in 1829 and is an excellent example of a two-story dogtrot log building. It was the first permanent courthouse for Izard County in Arkansas Territory. Those traveling with Benge's detachment would have seen this building on their way to Indian Territory.*

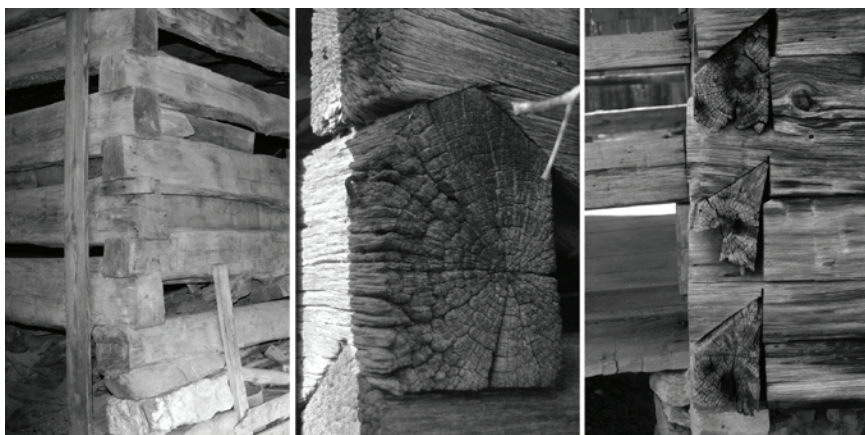
*(Left) Square notch, ca. 1836 corn crib at the Crider Tavern Complex in Caldwell County, Kentucky; (center) V-notch, ca. 1810 outbuilding at the George A. West Complex in Robertson County, Tennessee; (right) Half-dovetail notch, ca. 1805 Vann's Tavern in Gordon County, Georgia.*

One of the most distinguishing features of a log house is its corner notch. Notches locked the logs in place, thus ensuring the structure's stability. The most commonly seen notch types on log buildings along the Trail of Tears National Historic Trail are square, V, and half-dovetail. Half-dovetail notches offer the most stability of the three. The square notch offers the least, as it does not allow the logs to lock in place; structures built with this notch type are significantly less stable and more susceptible to collapse.

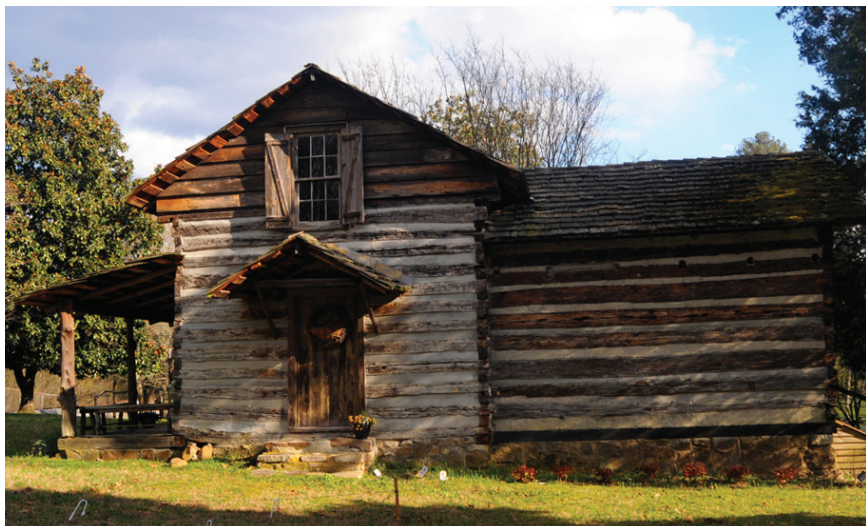
Log structures in warm climates were set on piers in order to allow air to circulate underneath. This air circulation kept the house cooler and helped keep wooden components (particularly sills and joists) from rotting. If infill was added between the piers air circulation decreased, making deterioration of the sills, joists, and lower logs more likely.

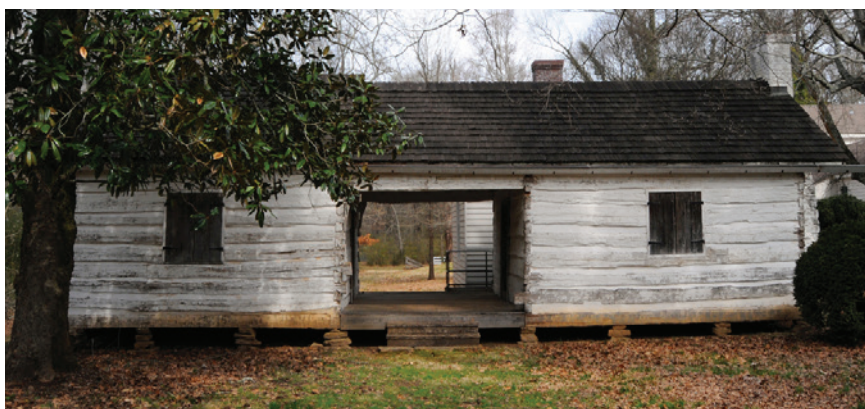
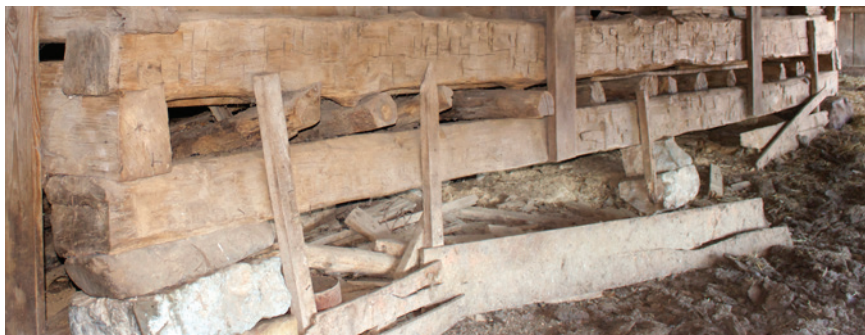
**Problem:** Settling. Settling occurs when the soil is unable to bear the load placed upon it or when the weight of the structure is concentrated in too small an area. The result is the unplanned movement of the building, which can lead to the cracking or tearing of finish materials and, in extreme cases, structural failure.

**Solution:** Install a concrete footing under the affected pier. A 12-inch-thick pad should extend at least six inches on all sides past the edge of the pier it supports. The bottom of the footing should rest below the frost line. In order to support the sill temporarily, set the cribbing back so that it is out of the way of the work. After establishing the proper height for the top of the foundation, remove the rocks of the existing pier and excavate the dirt where the footing will be placed. Lay in several pieces of half-inch rebar if the bearing soil is unstable. Pour and level concrete. Lay up the rock and level the sill with wood shims. For a more ambitious plan of replacing (or installing) a continuous foundation, the procedure above can be used for one section at a time.

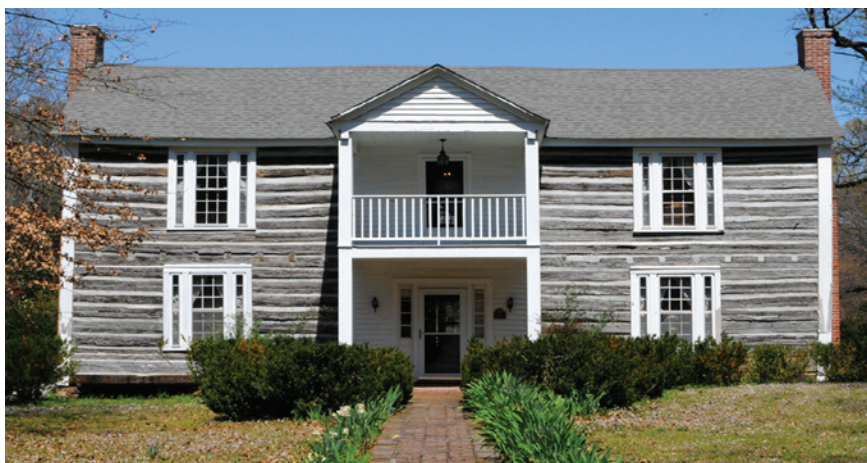
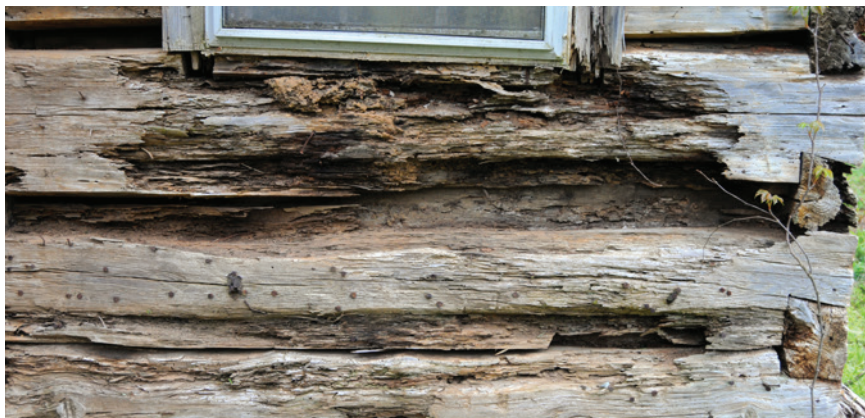
**Problem:** Deteriorated Log End. The end of the log can no longer bear the weight upon it.

**Solution:** Carefully remove all deteriorated wood near the end of the log. Form a small piece of wood into the shape of the wood that was removed, and insert the formed wood block into the space.

**Problem:** Deteriorated Log End. The end of the log can no longer bear the weight upon it, but concern for appearance prohibits the use of wood block repair.

**Solution:** Inject a sufficient amount of a two-part epoxy compound into the end of the log. Complete the form of the notch with the paste-like material. This is a very expensive repair and should be used for projects where appearance or authenticity is especially important.

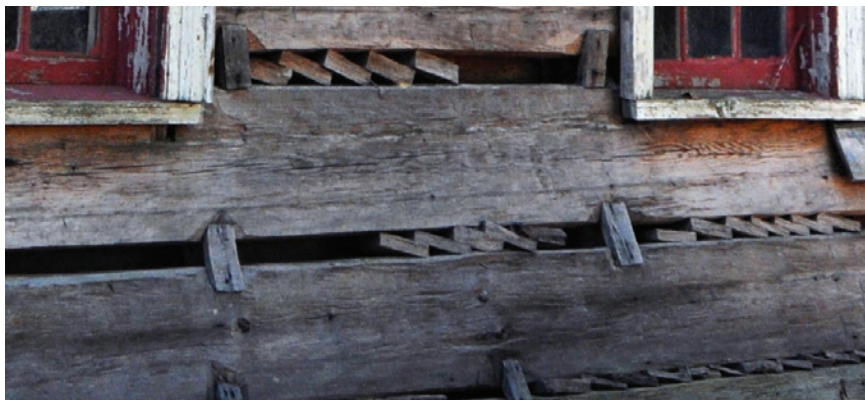
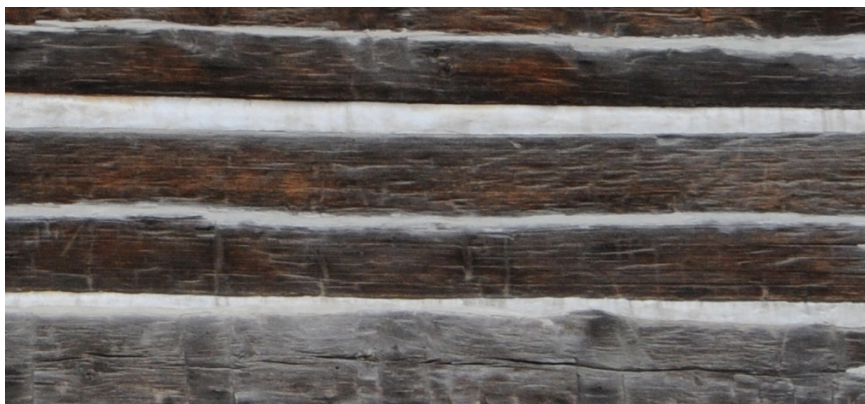
**Problem:** Broken and/or Missing Daubing. Cracked or missing daubing can cause potentially damaging exposure to weather.

**Solution:** Remove all daubing that is not solidly affixed to the chinking and brush away all dust. Make sure all chinking is firmly in place and fill in where needed. Either traditional chinking or expanded metal lath can be used. After moistening the area to be worked on, use a mixture of one part Portland cement, four to eight parts lime, and seven to ten parts sand to fill in the empty spaces.

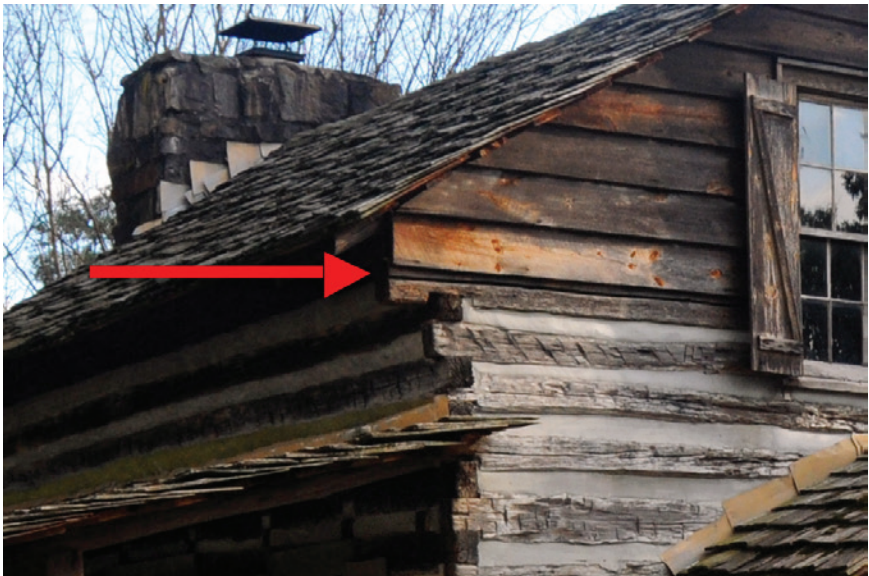
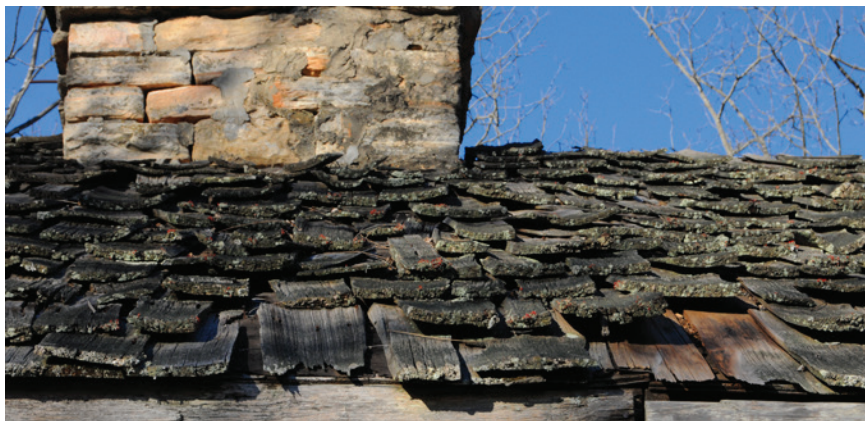
**Problem:** Deterioration. These large timbers often suffer considerable damage caused by roof leaks.

**Solution:** Small areas of deterioration can be repaired using the same methods used in sill repair, but greater damage requires reinforcement or replacement. Steel plates and/or angle irons usually can be installed in places not exposed to view, such as the rear or top of the beam. Sometimes a portion of the beam must be removed to accommodate the steel reinforcement pieces.

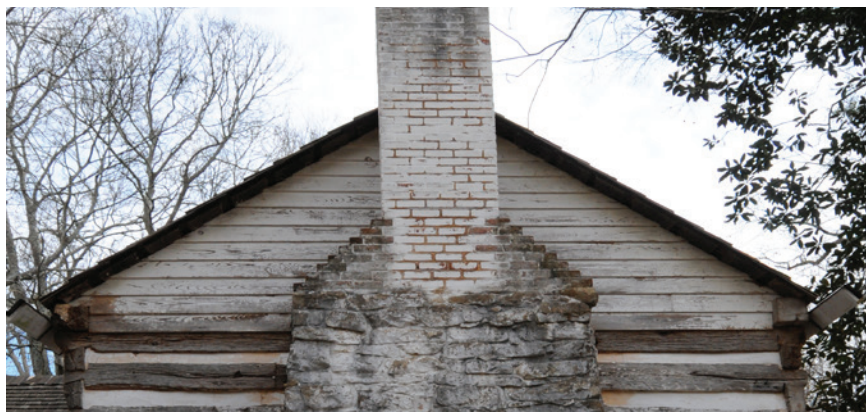
**Problem:** Deteriorated Siding. Worn siding admits weather to the building.

**Solution:** The original siding consisted of yellow poplar, which still can be found commercially. These days, lap siding is more commonly available in western woods (such as cedar, spruce, pine, and fir), which are acceptable substitutes. Replacement of worn or deteriorated lap siding should be done on a piece-by-piece basis. Carefully remove unusable pieces. The new siding should be nailed with noncorrosive fasteners. Lap each piece  $\frac{3}{4}$ " over the previous one and place the nails so that the top siding board is not fastened to the lower one.

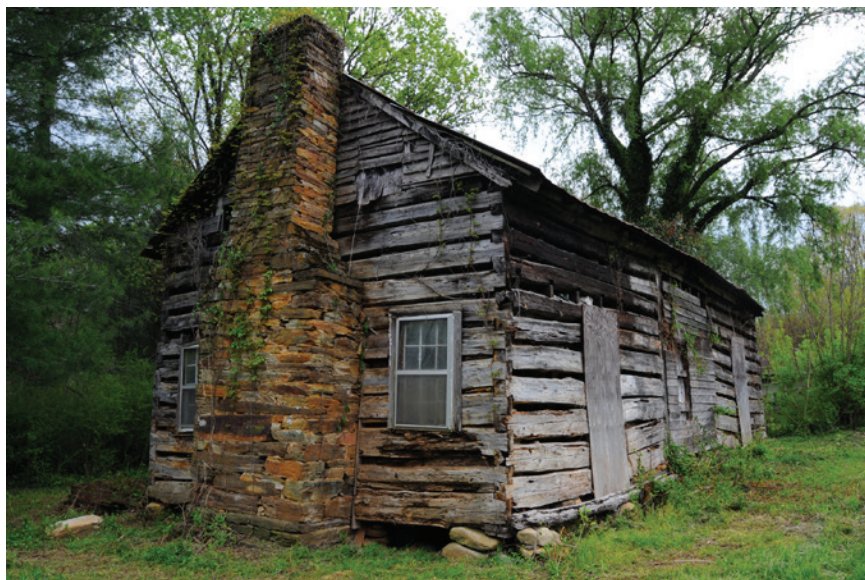
**Problem:** Cracking of Masonry Due to Repointing with Portland Cement. Excessive Portland cement use often leads to the fracturing of bricks or stones.

**Solution:** Carefully remove old Portland cement from affected joints with a cold chisel and repoint with a softer lime-based mortar.
